NATIONAL TRANSPORTATION SAFETY BOARD

FIRE INVESTIGATION FACTUAL REPORT

Report No. 13-014

Place : Boston, MA
Date : 1/7/2013
Vehicle : Boeing B787, JA829J
NTSB No. : DCA13IA037
Investigator : David Helson

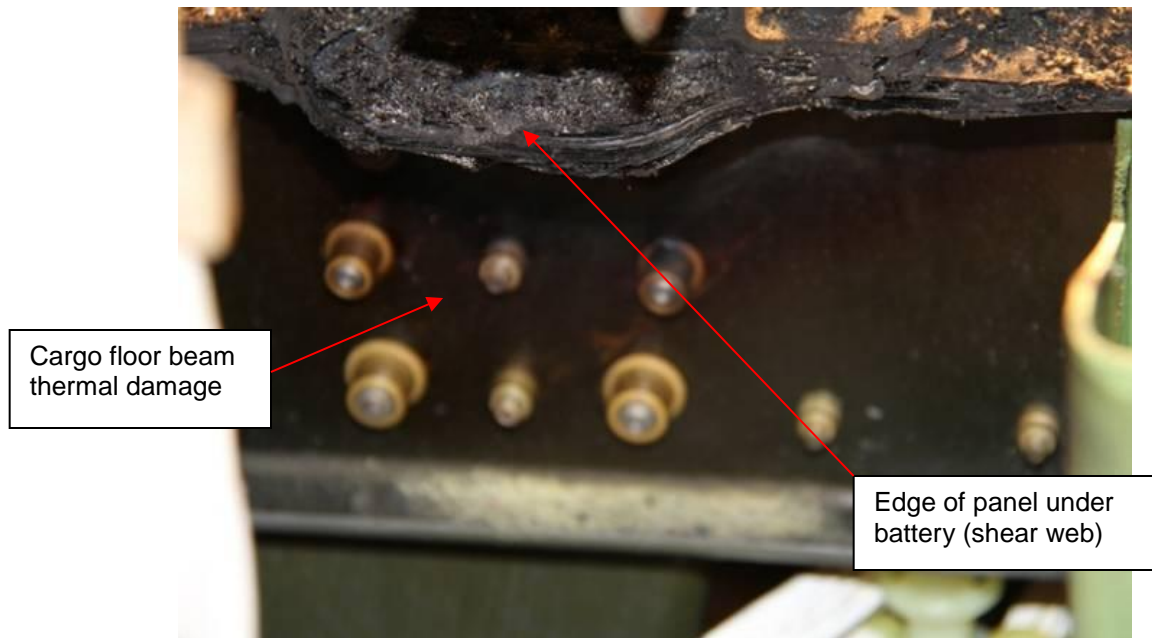
Figure 30: Rear edge of panel under back right corner of battery.

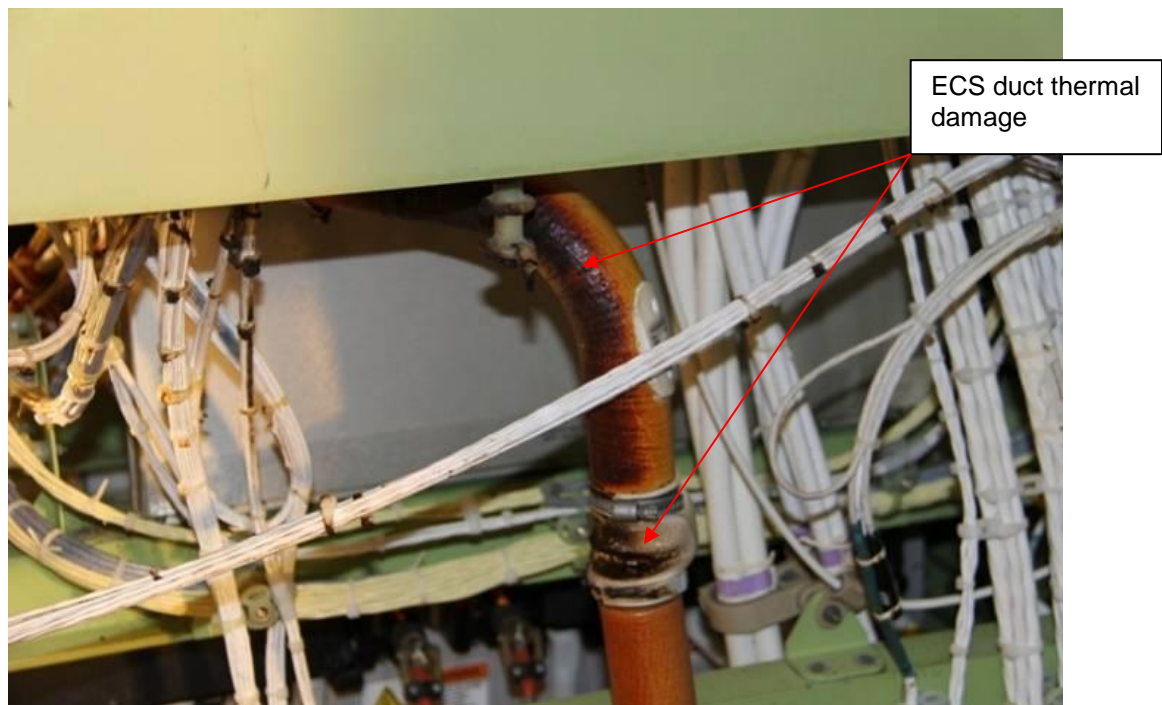
Figure 31: Thermal damage to ECS duct and standoffs. This area would be behind and above to the A/C right of the battery.

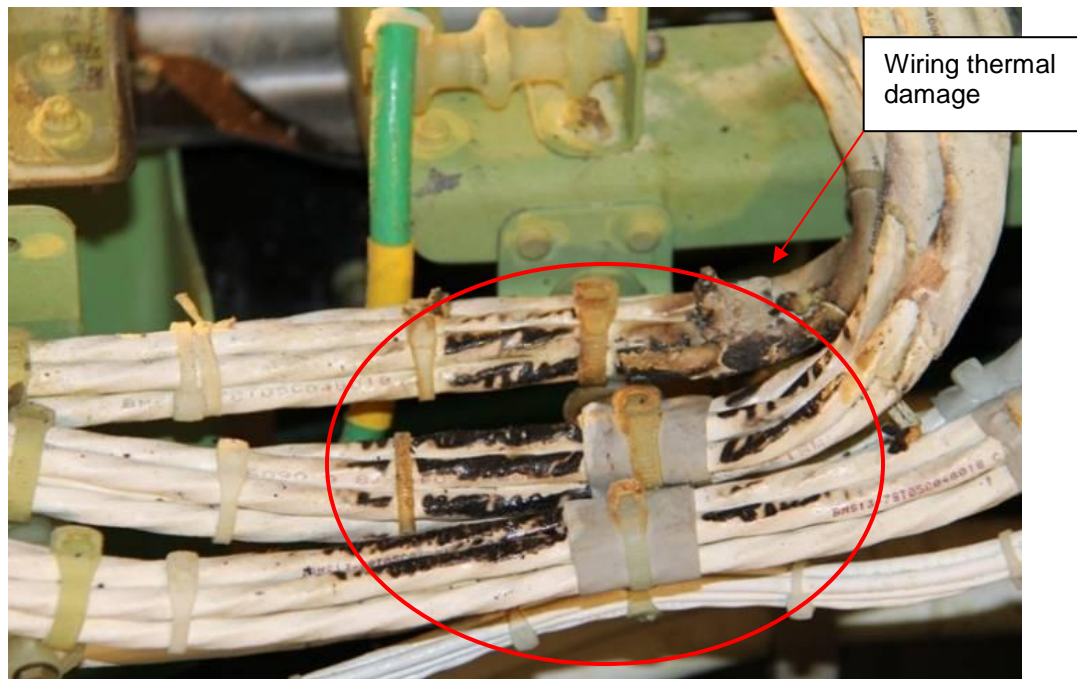
Figure 32: Thermal damage to wiring. This area would be behind and to the A/C right of the battery, below the location shown in figure 31.
